Precision Parts

Jun 2003

# LIVE WIRE

## FOS315

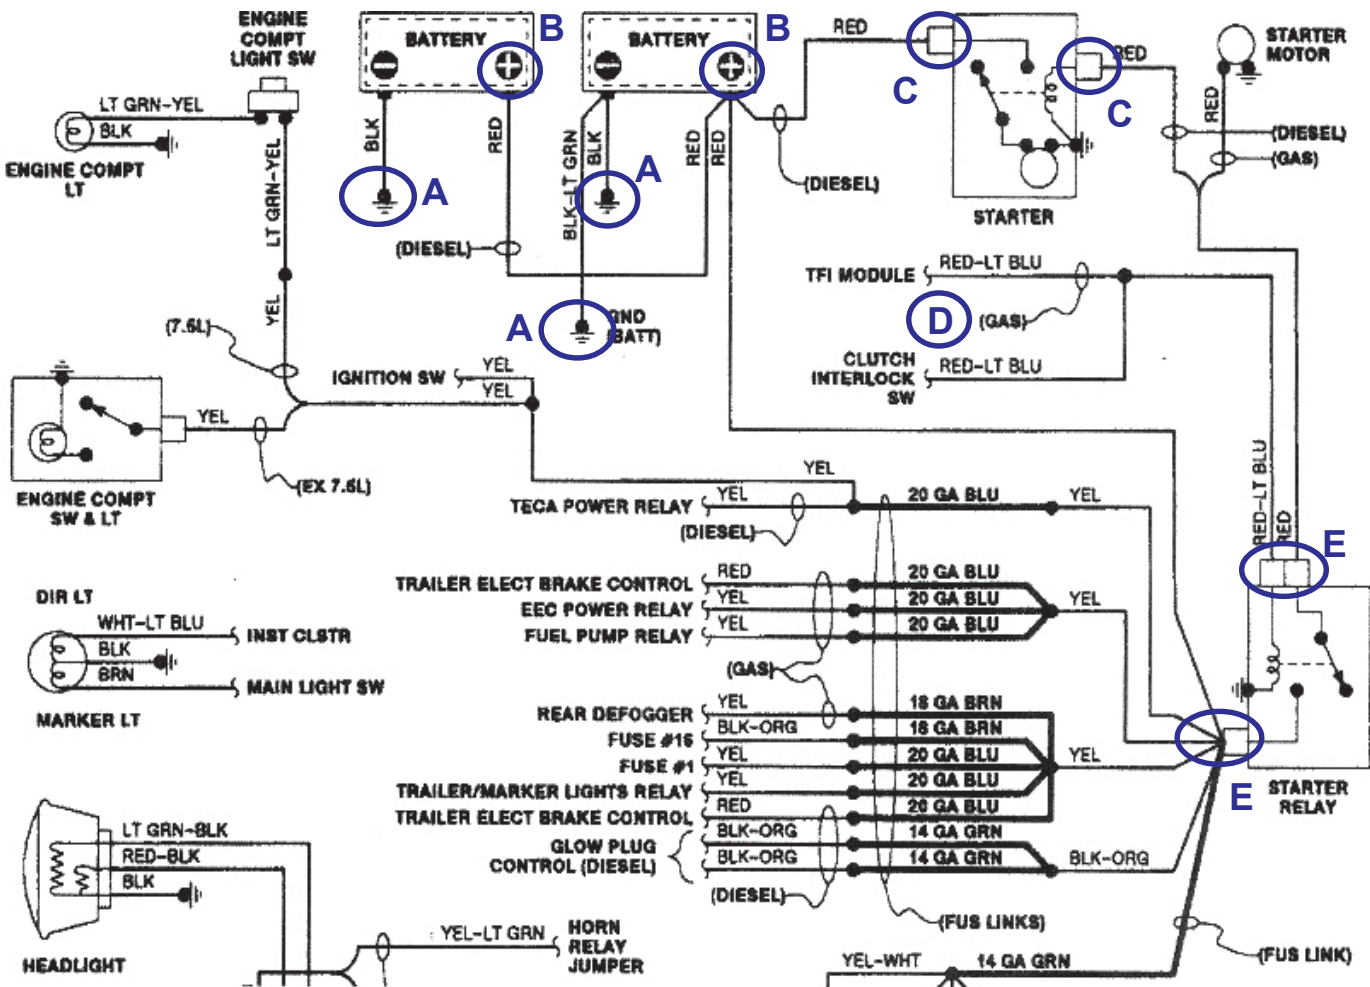
Typical Wiring Diagram for Ford 6.9 and 7.3 Diesel

\*\*\*\*\* #1 cause of starter failure or failure to operate is due to low ignition switch voltage and low battery voltage \*\*\*\*\*

The major cause of the starters not operating on these applications is due to **high resistance** in the starter ignition switch circuit and low battery voltage due to poor battery and/or battery cable connections. If the starter does not operate or just clicks follow the instructions on page 3 and check the items below **before** removing the starter. Items to be checked are all battery ground connections (**A**), Battery Connections(**B**),**voltage drops in these connections will result in low cranking power or starter not cranking**. Starter Connections (**C**), Clutch Interlock Switch (or Gear Selector Switch if A/T) (**D**), Starter Relay Connections (**E**). Ignition switch and connections upstream from the Clutch Interlock Switch (**D**) must also be checked. **Voltage drops across any of these items will keep the starter from operating correctly.**

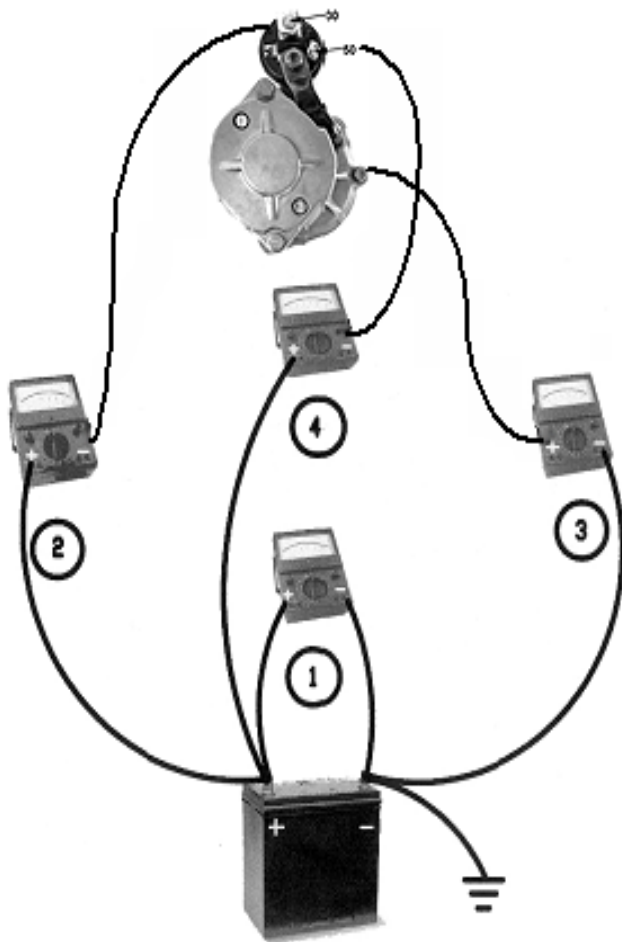
# Starter System Voltage Drop Steps

\*\*\* All steps must be done while cranking the engine \*\*\*

**Step 1** Record voltage at the battery while cranking the engine.  
 Volts

**Stop** If the battery has **less than 10 volts** while cranking, the **battery is bad.**

**Step 2** Record the voltage drop at the starter while cranking the engine.  
 Volts

**Step 3** Record the voltage drop at the starter housing while cranking the engine.  
 Volts

**Step 4** Record the voltage drop at the starter switch circuit while cranking the engine.  
 Volts

**Stop** If the voltage reading is **over .2 volts**, **Repair:** the battery cable and all connections; connections must be cleaned and repaired.

**Stop** If the voltage reading is **over .2 volts**, **Repair:** ground cable and all connections; connections must be cleaned and repaired.

**Stop** If the voltage reading is **over .3 volts**, **Repair:** switch circuit, related components and all connections must be cleaned and repaired.

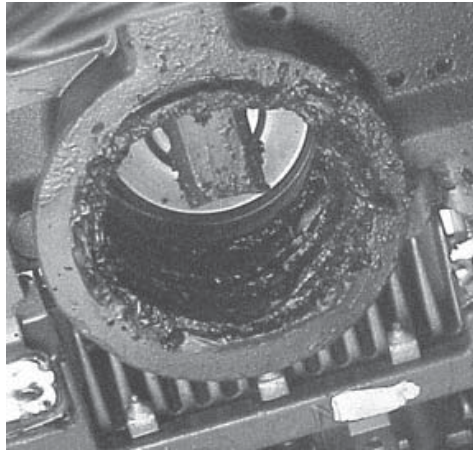
However, by checking incoming cores over a period of months, we have detected a consistent pattern of **oil soaked** alternators. Whether the units are OE, or remanufactured, the trend is the same. The units often are coated all over, making it difficult to determine a set source of oil leakage.

1. **Oil accumulation** in the brush to slipring area, resulting in premature brush wear, and excessive grit build up. See following image.

While not all DOA786 application charging problems can be attributed to oil contamination, it certainly is a factor to be addressed to improve charging system reliability. When a core arrives at your store with oil contamination, it needs to be pointed out to the customer as a problem to be addressed. Curing oil leaks also can benefit other systems in the under the hood area, if for no other reason than improved heat dissipation.

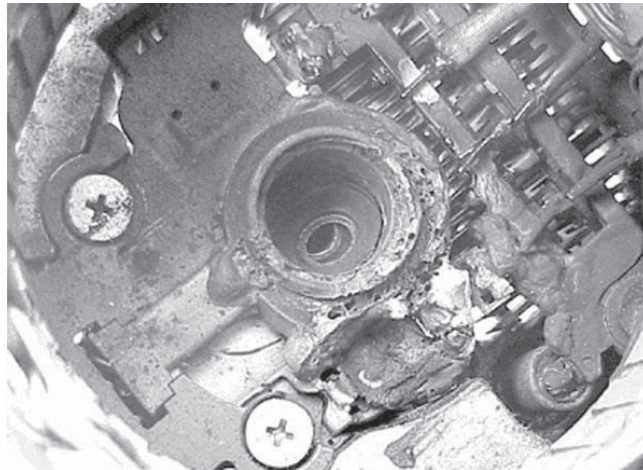
3. On occasion, we have seen cores that had internal **fires**, possibly attributed to oil contamination. See image below.
