Precision Parts

Nov. 2007

Volume 9, Issue 3

LIVE WIRE

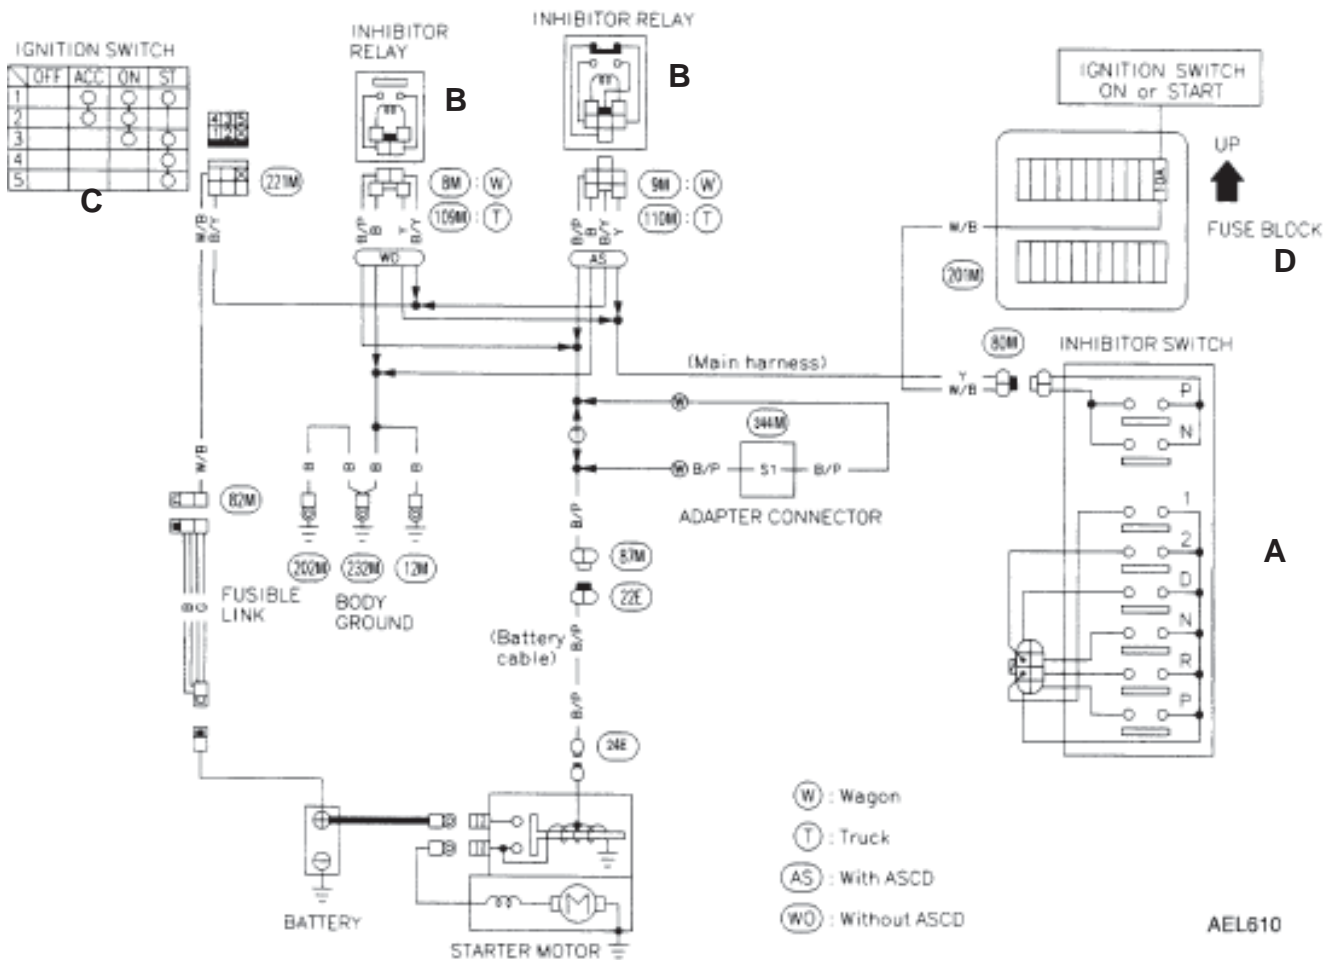
Items/Areas of Concern

- A** Inhibitor Switch, check for correct operation
- B** Inhibitor Relays, check for correct operation
- C** Ignition Switch, check for correct operation
- D** Fuse, check for open circuit

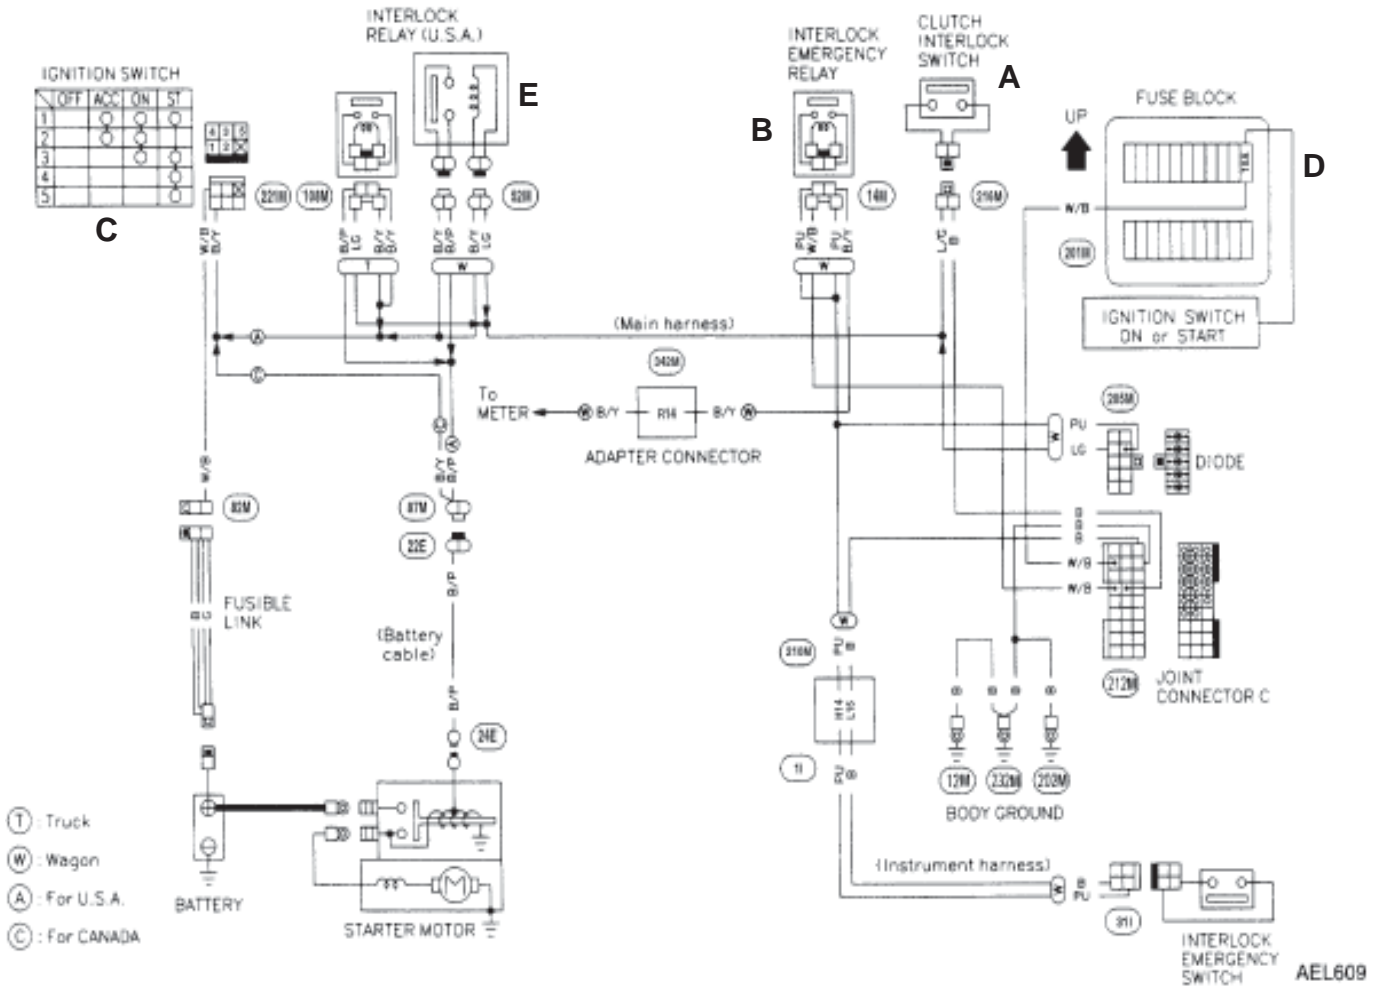
Items/Areas of Concern

- A Clutch Interlock Switch, check for correct operation
- B Interlock Emergency Relay, check for correct operation
- C Ignition Switch, check for correct operation
- D Fuse, check for open circuit
- E Interlock Relay, check for correct operation

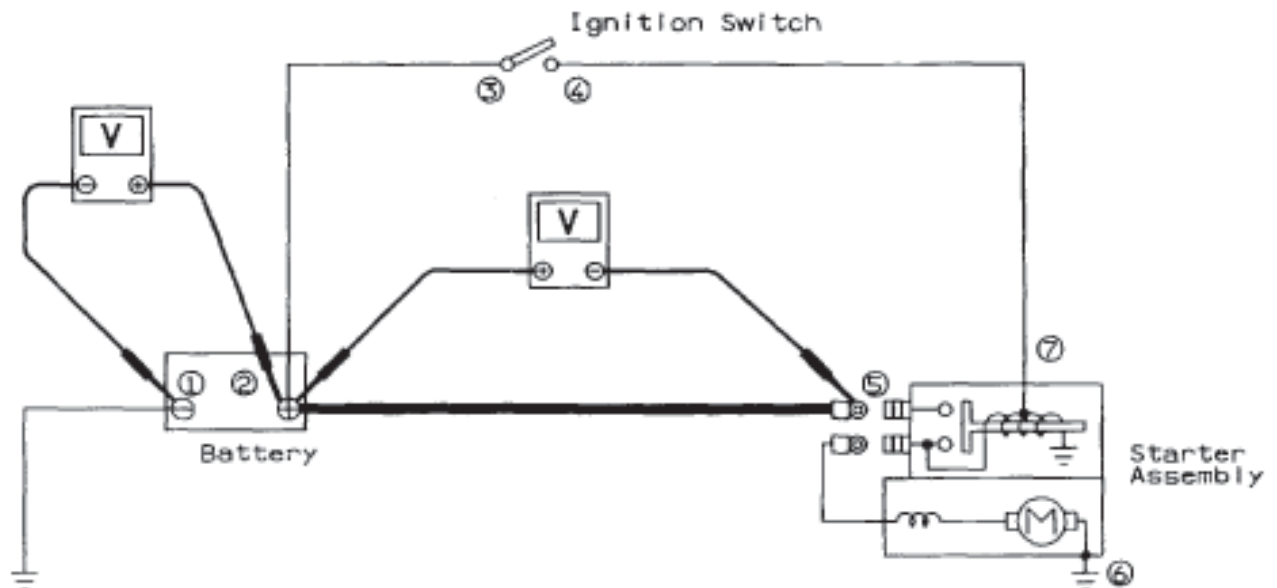
Test Points:

TERMINALS	VOLTS	AMPS	CONDITION
1(-) & 2(+)	12.8	-	no load
1(-) & 2(+)	11.2	-	while cranking
Between 2 & 5	-	60.0	while cranking
2(+) & 5(-)	0.2	-	while cranking
6(+) & 1(-)	0.15	-	while cranking
2(+) & 7(-)	0.82	-	while cranking
Between 4 & 7	-	20.0	while cranking
2(+) & 3(-)	0.17	-	while cranking
3(+) & 4(-)	0.18	-	while cranking
4(+) & 7(-)	0.29	-	while cranking

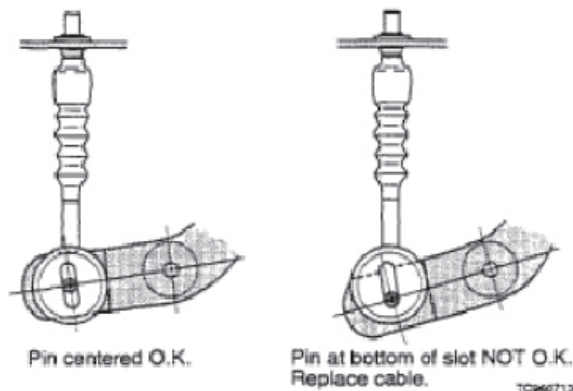
Condition: If a 1993-96 Altima vehicle with A/T has an intermittent no crank condition when the shift lever is in the "Park" position, the cause may be an A/T control cable that is approximately 2mm (0.08 in.) shorter than specified.

3. Check the position of the control cable slot, in relation to the pin on the manual shaft.
 - A. If the pin is centered in the slot then the A/T control cable is the correct length and no adjust/replacement is necessary.
 - B. If the pin is at the lower end of the cable slot as shown, you should replace the A/T control cable.

For instructions on replacing the A/T control cable, see the PPR website for the full text of this service bulletin. <http://www.pprk.com>
