Precision Parts

Volume 6, Issue 1

# LIVE WIRE

## Overrunning Clutch Pulley

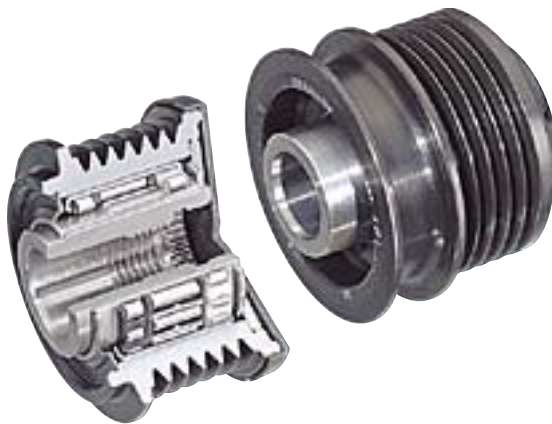
Overrunning alternator pulley  
(courtesy of INA Bearing)

An overrunning alternator pulley differs from your standard alternator pulley. It still has the single or multiple grooves that matches your alternator belt. But internally is where the difference can be seen. The alternator pulley that you are familiar with is just a piece of steel or some other material. The overrunning alternator pulley has a one way clutch inside of the pulley. There are various designs depending upon the manufacturer. Some manufacturers use a roller clutch and some manufacturers use a one-way wrap spring clutch. Another important difference is how the pulley attaches to the alternator shaft. In the conventional pulley (no overrunning clutch) the pulley attaches to the shaft with a nut and lockwasher. In the overrunning clutch pulley, the inner race of the clutch acts as the nut and screws on to the shaft. Special tooling is required for the removal and installation of this type of pulley.

The main reason the auto manufacturers use the overrunning clutch is to absorb vibrations and fluctuations in the accessory drive belt system. As you increase and decrease engine speed the alternator must keep up with these changes. In the standard pulley (no overrunning clutch) system, the alternator belt has a tendency to slip (belt chirp) on the deceleration phase of engine operation. This is due to the mass and inertia of the alternator rotor assembly.

This slippage results in belt wear and irregular pulses introduced into the belt drive system. These irregular pulses cause wear on other accessories in the belt drive system. The overrunning clutch disengages the alternator from the belt drive system during the deceleration phase of engine operation. This has 2 advantages. The belt does not slip which reduces belt wear and the alternator does not have catch up with the acceleration phase on the next cycle resulting in a smoother pulse and more efficient engine loading. The benefits of this type of pulley system are more readily seen on vehicles that have rapid speed changes as well as high alternator loads. Systems using these types of pulleys have less belt noise (no chirping during speed changes) and smoother idle operation. This type of belt drive system has been popular in the heavy truck industry on diesel and odd cylinder engines in Europe.

**Note: Caution your customers about trying to remove this type of pulley. It takes special tooling to remove these pulleys without damaging the rotor shaft. It is recommended to not reuse the overrunning clutch pulley. Care must be taken when installing a unit with an overrunning clutch. Excessive force or a blow to the pulley can damage the clutch mechanism resulting in premature failure of the overrunning clutch pulley.**
